# Self-repairing mechanism and surface characterization of compressor vanes lubricated with oil added with magnesium silicate hydroxide nanorods

**Abstract.** Using magnesium silicate hydroxide as additive of lubricating oils for reducing friction in engineering equipment/machinery has been researched intensively. However, some mechanism relating to the growth of the self-repairing layers on the worn surfaces is still not clearly explained. At the same time, using magnesium silicate hydroxide (MSH) in the form of nanorods showed great promise in reducing friction and wear. In this study, surface-modified MSH in the form of nanorods was used as additive of polyolester oil (POE) which was then used for the lubrication of compressor vanes. The sample parts were studied on the morphology and the microstructure of the self-repairing layer in a great depth. The results showed that self-repairing layers with different thicknesses were generated on the worn surfaces when the POE with 1 wt.% nanorods-MSH was used. It was found that the self-repairing layers consist of organic-inorganic composite membranes, and with increase of working time of the compressor vanes, the self-repairing layers

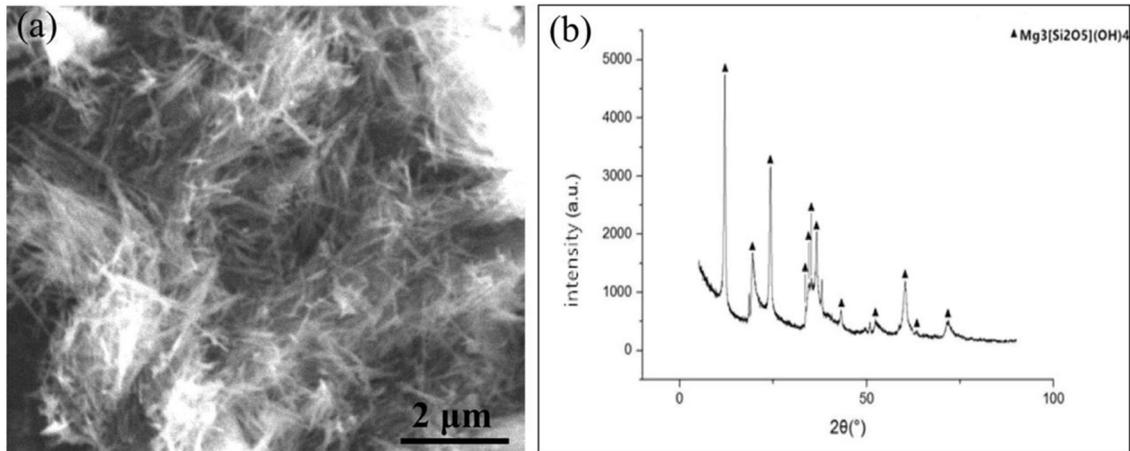
**Fig. 1.** (a). SEM image of MSH nanorods and (b) XRD of MSH nanorods.

neutral, and finally, it was dried with a dryer at about 100 °C for 12 h. After being dried, as shown in Figure 1a, the product was an aggregate of nanorods. The morphology of the synthesized product is shown in Figure 1a. Results of XRD analysis (Fig. 1b) showed that the nanorods are pure MSH and they have good crystallinity. To obtain good dispersity in the oil, the MSH nanorods were mixed with 1 wt.% oleic acid in a planetary ball-mill at 400 rpm for 24 h to obtain nanorods (Fig. 2). As can be seen from Figure 2, the inner diameter of the nanotubes is 5–10 nm and the outer diameter is about 30–40 nm. The surface-modified MSH nanorods have good dispersity. Finally, ultrasonic dispersion (power 200 W, temperature 50 °C, duration 60 min) was used to further ensure uniform dispersion in the POE oil.

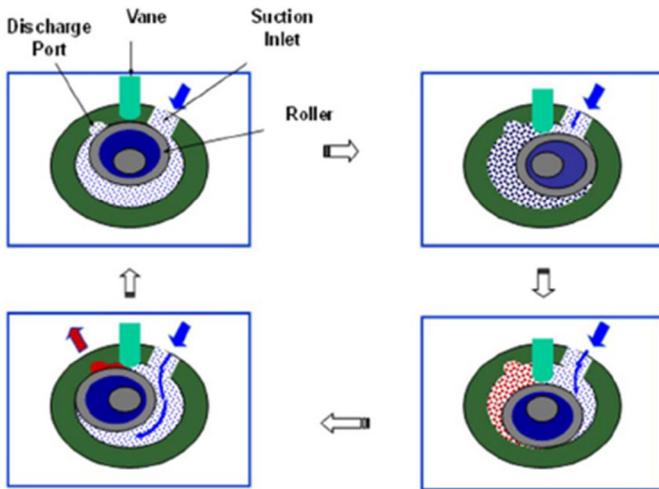
Fig. 3. Relative motion of roller-vane friction pairs.

The relative motion of roller-vane friction pairing in the compressor is shown in Figure 3. In order to simulate real working conditions of a vane, a testing apparatus was built (shown in Fig. 4). The apparatus enabled two steel-vanes to be held against a rotating roller in an environment with nanorods-additive containing oil. Firstly, the surface-modified MSH nanorods were dispersed in the POE with a

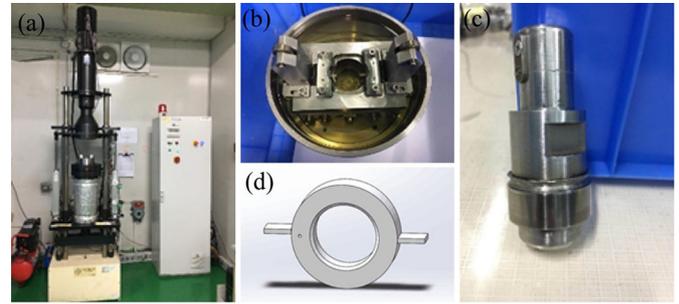
Fig. 4. Experimental apparatus: (a) wear testing machine, (b) oil pool, (c) roller, and (d) assembly model.

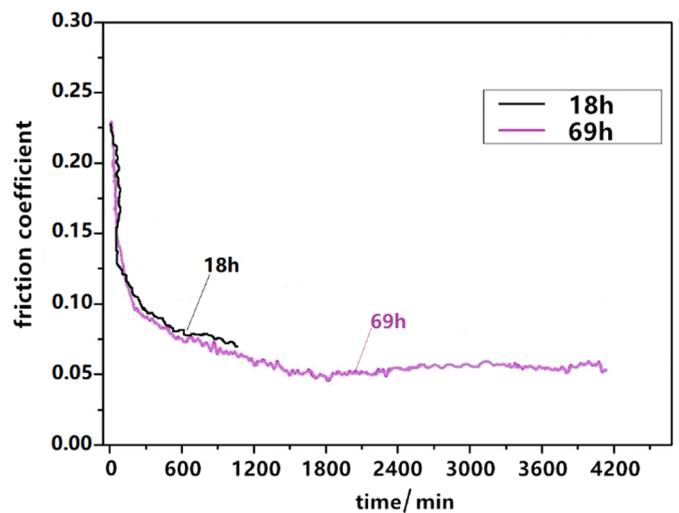
Fig. 5. Friction coefficient for tests A and B.

Figure 5 shows how the friction coefficient varies with testing time for two experiments. Because of being similar in work conditions, two curves are virtually similar, up to the test time of 18 h. The coefficient begins at a value of about 0.225 and then sharply declines to a value of about 0.10 during the first 60 min. Then the coefficient reduces more gradually to a value of about 0.075 after 18 h

It is deduced that by prolonging the rubbing time, the coefficient of friction has a declining trend, but the coefficient has a fluctuation in small range towards the end. It is deduced that in the first hour the coefficient sharply decreased from 0.225 to 0.10 for the running-in of the rubbing interface, and fluctuated in a small range throughout the experiment. The friction between the vane-roller is boundary friction and the coefficient of friction is determined by a combination of the fluid friction and the solid friction. The solid friction is greatly influenced by the wear rate and the formation of self-repairing layers. Therefore, the coefficient exhibits a slight fluctuation until the dynamic balance between the wear and new-film formation has been achieved.

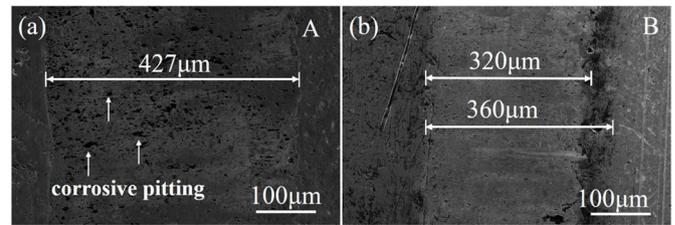
Fig. 6. Image of the worn surface of samples A and B.

Figure 6 shows the morphology of the worn surface of the two vanes. The width of the worn surface of vane A is about  $427\ \mu\text{m}$ , and there is much corrosive pitting in the friction surface. The width of the worn surface on vane B is about  $330\ \mu\text{m}$ . The characteristics of the worn surfaces change from one side of the vane to another. The friction surface was divided into two zones, shown in two different colors: the left side of the worn surface is black and the right bright. It seems that some special substance has been laid on the worn surface and there are fewer corrosive pitting points. Since the vane suffers from elastic deformation during the experiment, thermodynamic conditions are different in the left side and the right side of the worn surface, which influences the formation of the self-repairing layers. This is probably why the morphology of the worn surface of B looks different due to the formation of self-repairing layers locally. In the experiment, left side of the surface first contacted with the roller, then the right side. The large area of the self-repairing layers in the right side of the worn surface of B may be a result of good preservation of the layers due to the relatively mild tribological condition. However, the boundary of A is more distinct than that of B.

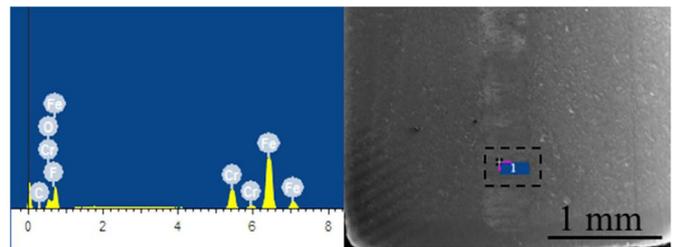
Fig. 7. EDS result for vane A.

The EDS result showed that the characteristic elements Mg and Si are contained in the bright region of A (Fig. 7). Since Si may come from the substrate, the presence of the Mg element indicates physical absorption or chemical reaction between MSH and the substrate.

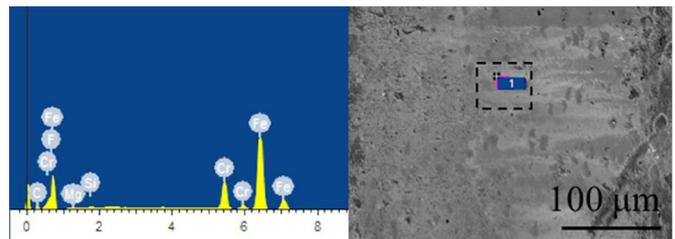
Fig. 8. EDS result for vane B.

Figure 8 shows the EDS result for B and the point is randomly selected in the friction surface. Since the RA410 is constituted by HFC, despite the element F, the other elements indicate that this is the substrate with carbon-enriched layer. The concentration of C is higher than that in the substrate, and it is deduced that the C is partly from the pyrolysis of the lubricating oil. The Mg element was also found on the surface.

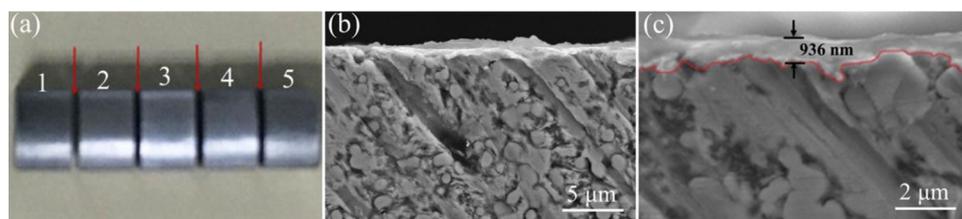
**Fig. 9.** Images of the cross-sections of vane A.

In order to observe the self-repairing layers from the cross-section, vane A was cut uniformly into 5 segments along axial direction of the rubbing surface (Fig. 9a). After polishing, grinding and corrosion of the cross-section the self-repairing layers were observed through a SEM. For the samples 1–4, morphologies of cross sections are mostly like what seen from the Figure 9b: there are no self-repairing layers observed from the cross-section of these samples. Only sample 5, as shown in Figure 9c, has a thin layer of about 900 nm laid on the friction surface. The layer is continuous and the boundary between the substrate and the layer is not clear. The red line indicates the approximate boundary of the layer, which is not a straight line and follows the contour of the substrate. However, surface of the layer is relatively flat. The morphology indicates that the self-repairing layer is an in situ-layer, and it automatically adapts to the micro-morphology of the substrate. There is no visible crack existing.

Figure 11 shows image of a self-repairing layer viewed from the cross-section of vane B and the line element distribution of the cross-section. Compared with Figure 9c, it is clear that the self-repairing layer generated on the friction surface is thicker. It also has flat surface and its boundary with the substrate is clear. Figure 11 also shows an EDS result, and the element type and change trend are similar to that shown in Figure 9b. These results indicate that with prolonged time, the self-repairing layer becomes denser and thicker, but the composition of the layer material remains the same.

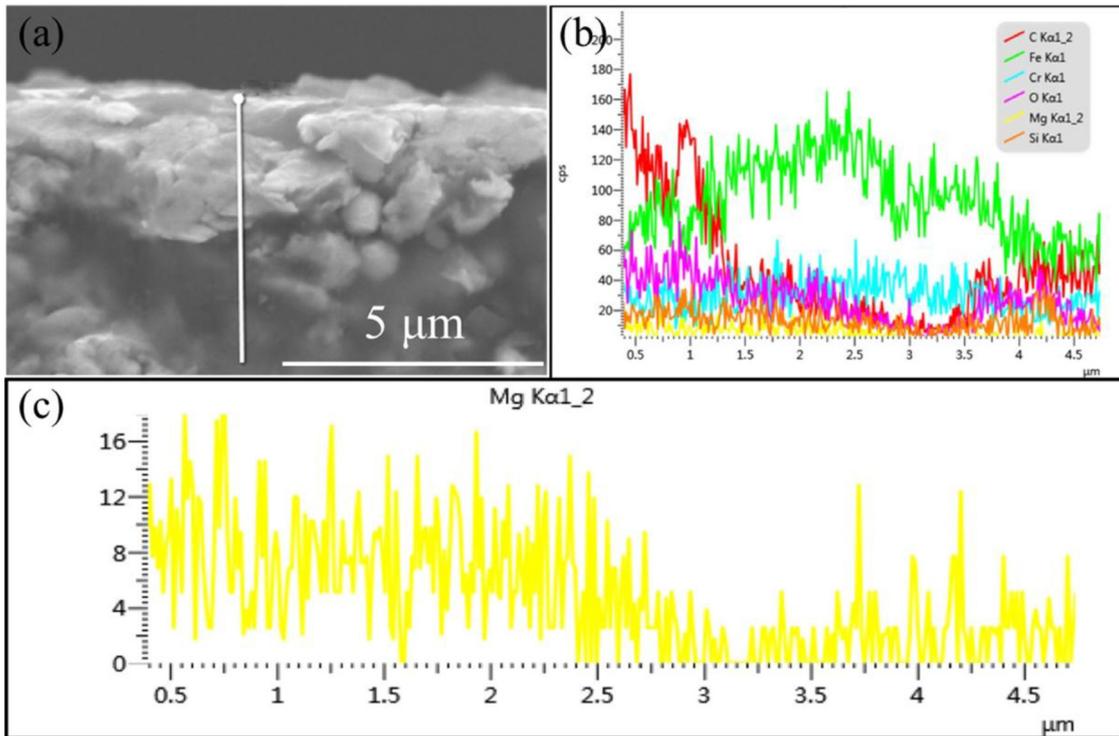
Fig. 10. Elements distribution from the layer to the substrate for vane A.

Analysis of element distribution is carried out by SEM-EDS. Figure 10 indicates that from the layer to the substrate, C elements decline sharply. Enriched carbon layers are less than 500 nm, which indicates the self-repairing layer has an organic – inorganic composite layer structure. In its surface a thin, enriched carbon layer was generated due to the pyrolysis of lubricating oil. The O element gradually reduced with distance from the layer to substrate where it remained constant. Relating to the result for the Fe element, it is deduced that the self-

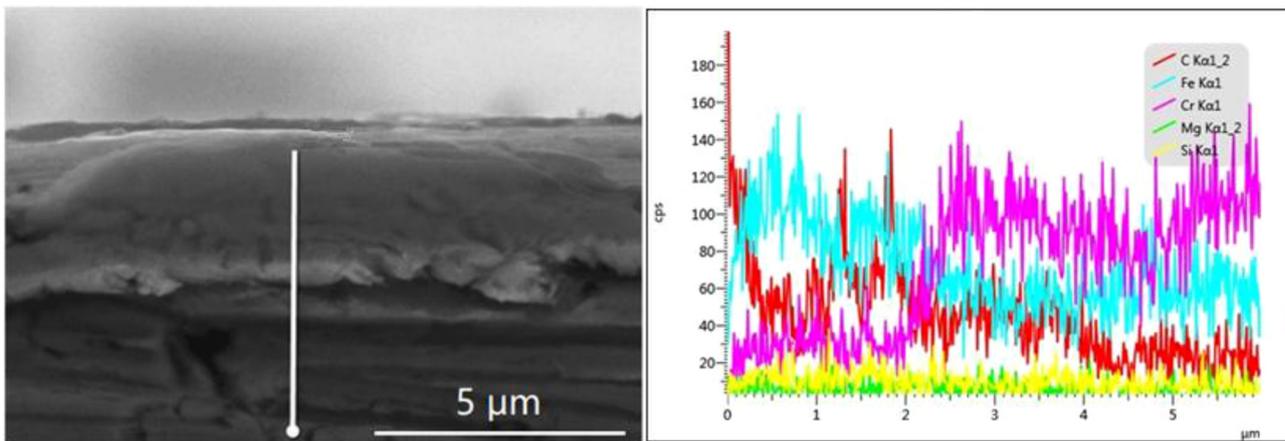
Fig. 11. Elements distribution from the layer to the substrate for vane B.

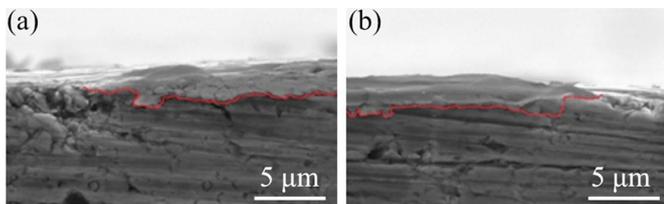
Fig. 12. SEM image of the worn surface: (a) left side of the worn surface, and (b) right side of the worn surface.

Figure 12 shows the boundary of the working surface and the non-working surface in cross-section. It is clear that the self-repairing layer is only generated on the working surface and its growth depends on the thermodynamic conditions of the friction interface. Therefore, the self-repairing process is in-situ growth of the layer.

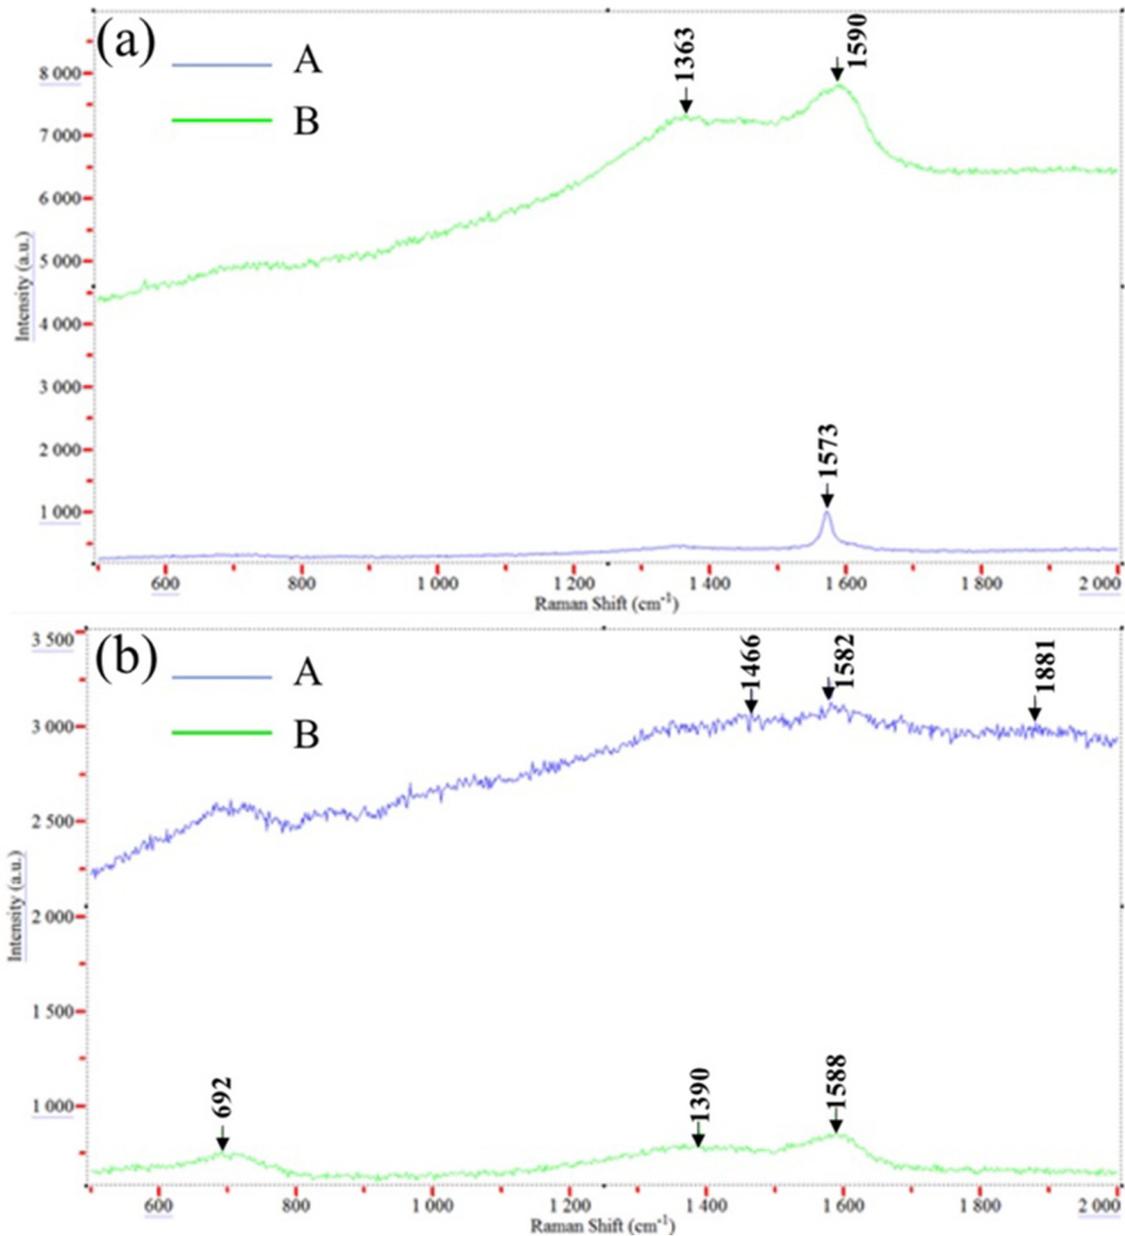
Fig. 13. Raman spectrum of vane A and B, (a) is the substrate and (b) is self-repairing layers.

The substrate and the self-repairing layer were analyzed by Raman spectrometry. The wave length was 532 nm, and the Raman displacement  $\Delta\nu$  was between 500 and 2000  $\text{cm}^{-1}$ . Figure 13a shows the result for the substrates of vanes A and B. The peak corresponds to 1363  $\text{cm}^{-1}$  (D-bond) near the peak of diamond (1332  $\text{cm}^{-1}$ ), and it is a symbol of the Sp<sup>3</sup> bond. Meanwhile, the peak corresponds to 1590  $\text{cm}^{-1}$  and 1573  $\text{cm}^{-1}$  (close to 1580  $\text{cm}^{-1}$ , “g-bond”) corresponds to the Sp<sup>2</sup> bond, which is graphite carbon.

Figure 13b shows the Raman results for the self-repairing layers of vane A and B. The peak corresponding to  $692\text{ cm}^{-1}$  is  $\text{Fe}_3\text{O}_4$ .  $1390\text{ cm}^{-1}$ (D-bond) and  $1466\text{ cm}^{-1}$  are near the peak of diamond ( $1332\text{ cm}^{-1}$ ) and signifies an Sp3 bond. The peak of  $1582$  and  $1588\text{ cm}^{-1}$  are near the  $1580\text{ cm}^{-1}$ (G-bond), and signifies an Sp2 bond. The peak of  $1881\text{ cm}^{-1}$  is not very clear. Therefore, it can be given no specific meaning.

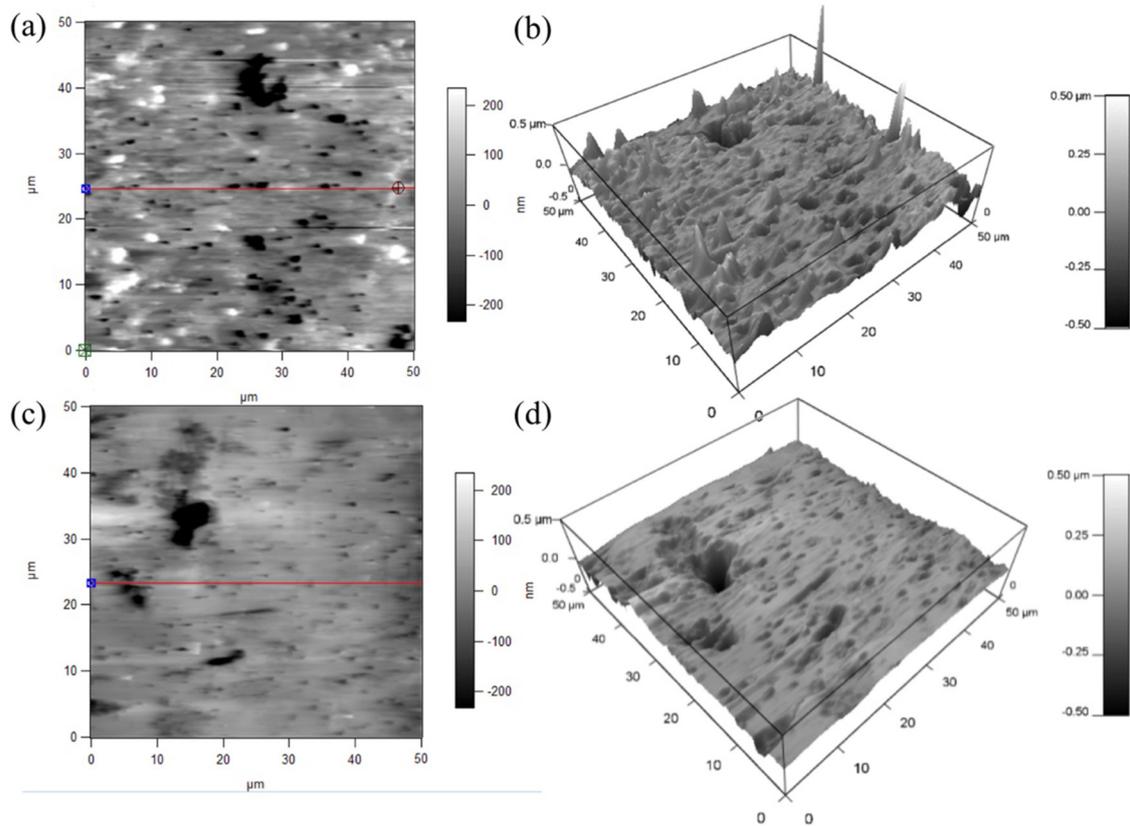
**Fig. 14.** AFM image of the worn surface layers: (a) and (b) are the worn surface of A, and (c) and (d) are the worn surface of B.

AFM analysis was used to present the micro-topography of the layers generated on the vane A and B. Figure 14 shows the micro-topography of the self-repairing layers for the worn surfaces of vane A and B respectively. Figure 15 shows the micro-roughness variation along the red lines in the two surfaces.

As can be seen in Figure 14a and b, there were many pits and humps in the worn surface of vane A, while Figure 14c and d show the surface of vane B to be smooth with only a few pits. In addition, the RMS for vane A is 89 nm, which is larger than that for the vane B (65 nm). Large humps appear in the surface of the vane A and the highest hump is 1267 nm, while it is 194 nm only for vane B. This shows, for a longer working time, the self-repairing layer becomes

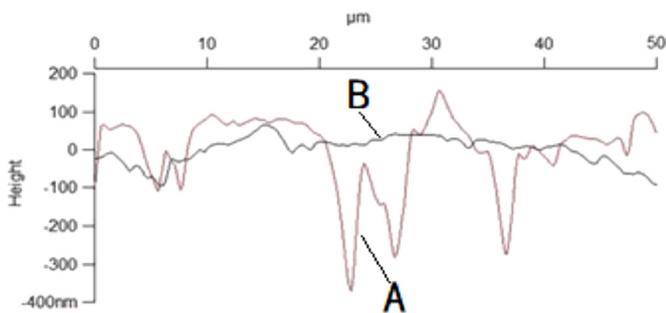
**Fig. 15.** Roughness variation for A and B.

thicker and microscopically smoother, which is also confirmed by a comparison on the roughness shown in Figure 15.

roughness of the substrate surface 0.105 and 0.110  $\mu\text{m}$ , respectively. For the worn surface, although the micro-roughness of the self-repairing layer for the vane B (Fig. 15) could be smaller than that for the vane A, the overall surface roughness was not improved significantly. The result may help to explain why some previous research reported that in similar experiment, the coefficient of friction became even larger when MSH was added into the oil as an additive. It may also mean that in a boundary lubrication, localized generation of the self-repairing layers could result in an increase of the micro-roughness of the worn-surface and hence, increase of the coefficient of friction. It may also be deduced that the use of MSH nanorods as an additive of the lubricating oil could compensate for the wear, and at the same time, reducing-friction and reducing wear are two competing processes, until self-repairing layers cover sufficient area of the wear while their roughness is also reduced due to new wear, which could be achieved by sufficient length of working time of a friction pair.
